Subject: Catch Basin Sampling for IPWP1- Work for Buildings 10, 11
Verification Sampling- MH6
Aqueous Sampling
Rainier Commons, LLC

Site Address: 3100 Airport Way S, Seattle, WA

NVL Project#: 2012-494

Attachment B: Site Observation Photos

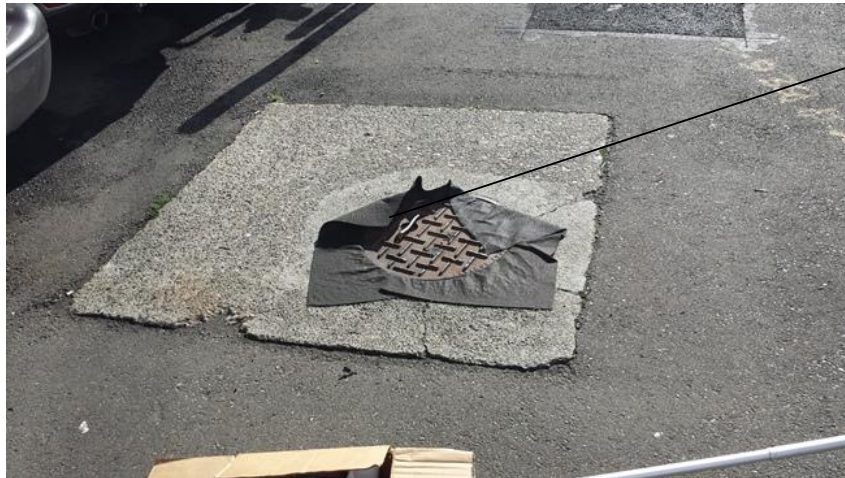
Manhole 6

The black filter sock seen here was observed to be intact that the time of sampling

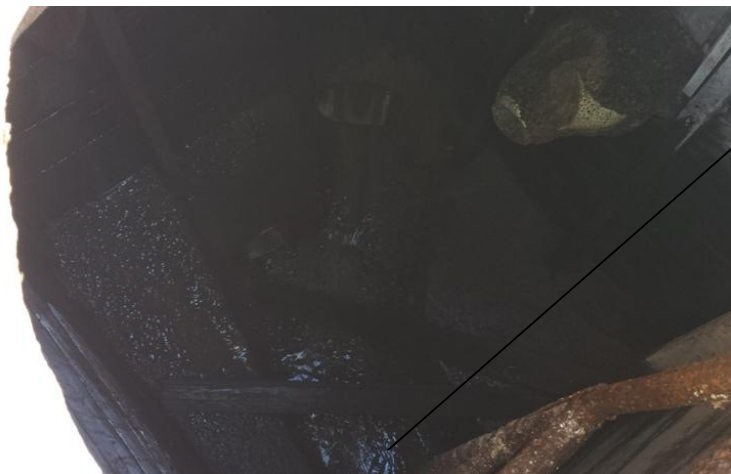
Manhole 6

Inadequate sediment for sampling was found in catch basin 3. Adequate water was present and an aqueous sample was collected here.

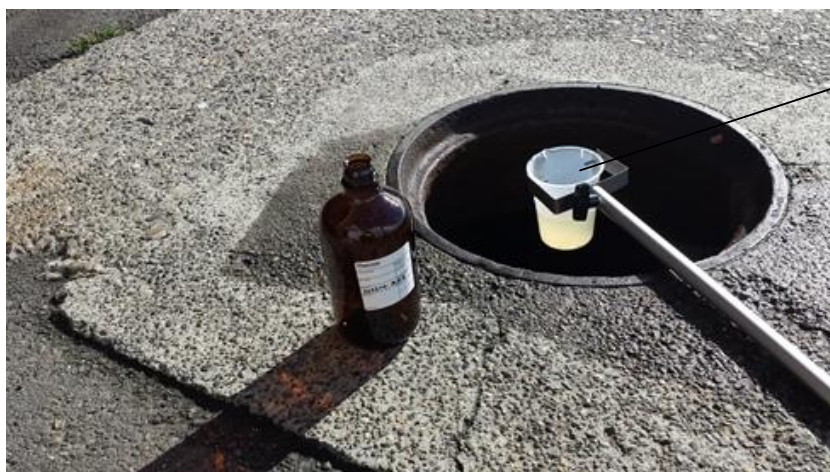
Sampling

A telescoping pole with disposable dipper beakers was used to collect aqueous samples from MH6.
